Manhole Inspection Summary

Manhole # S21MM1002MH

Location Address: **1503 OLD COLD SPRING LN**

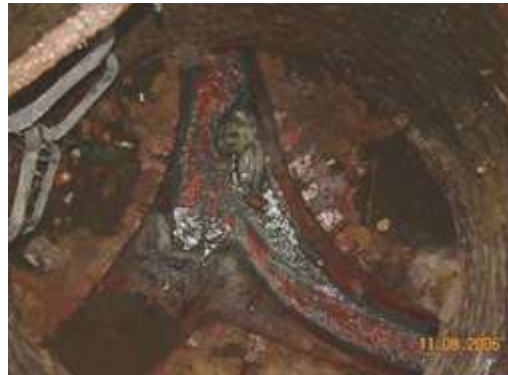
Top View

Corroded steps. Barrel infiltration.
Evidence of surcharge - Bench debris.
Channel debris.

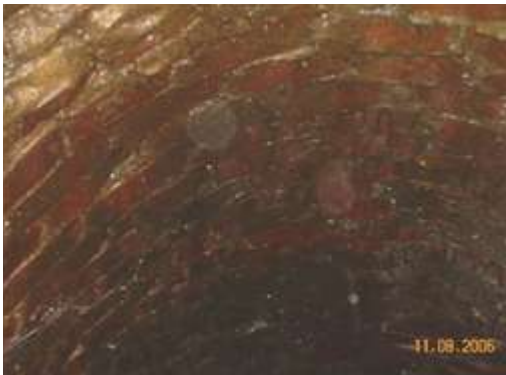
Defect

Frame leaks. Adjustment and Barrel infiltration.

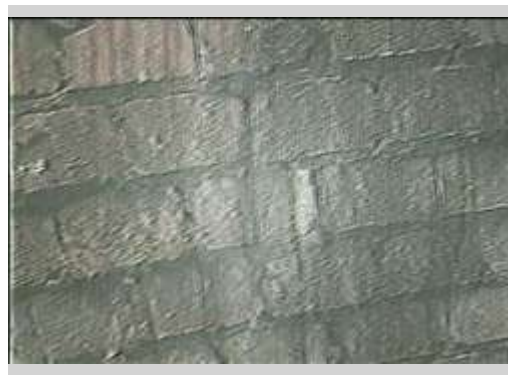
Defect

Frame leaks. Adjustment deterioration and infiltration.

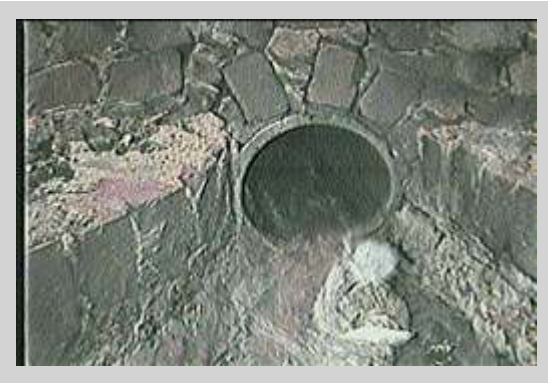
Pipe Out @ 12 O'Clock

Barrel deterioration and infiltration. Channel deterioration.

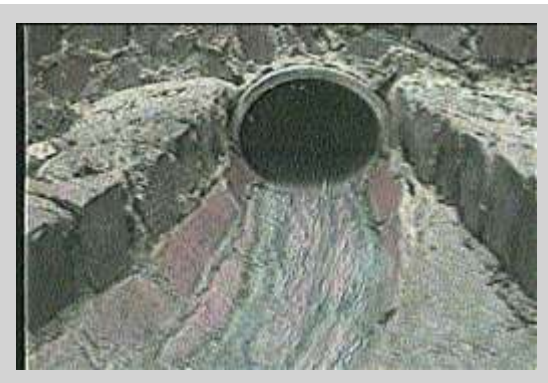
Pipe In @ 4 O'Clock

Barrel deterioration and infiltration. Channel deterioration.
